IED Report

TITLE: (EXPLOSIVE HAZARD) IED EXPLOSION RPT (Directional IED) C/ 6-9
CAV : 0 INJ/DAM

Narrative / Background

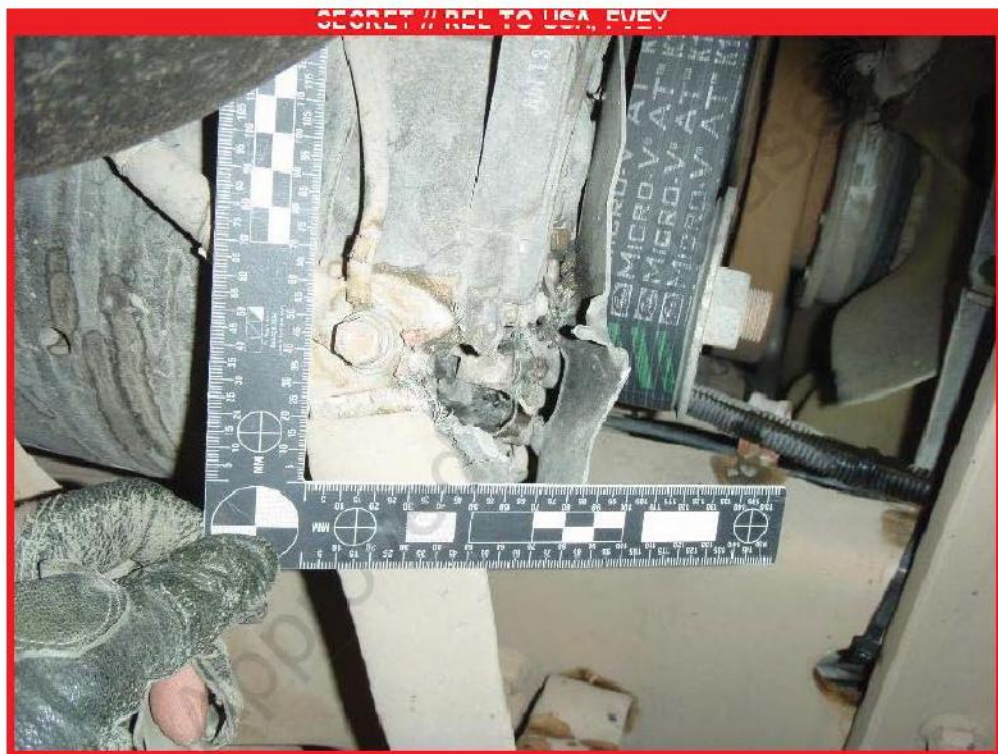
THROUGHOUT THE ENGINE COMPARTMENT. INTERNAL DAMAGE WAS NOTED ON THE ALTERNATOR, RADIATOR AND HOSES, ENGINE FAN AND SHROUD, AND WIRING. BOTH FRONT TIRES SUSTAINED FRAGMENTATION DAMAGE AND WERE FLAT. THE DAMAGE RESULTED IN A MOBILITY KILL, BUT NO CASUALTIES. IP EOD EXPLOITED THE SCENE AND FOUND NO EVIDENCE OR INITIATION SYSTEM.

Damage to alternator.

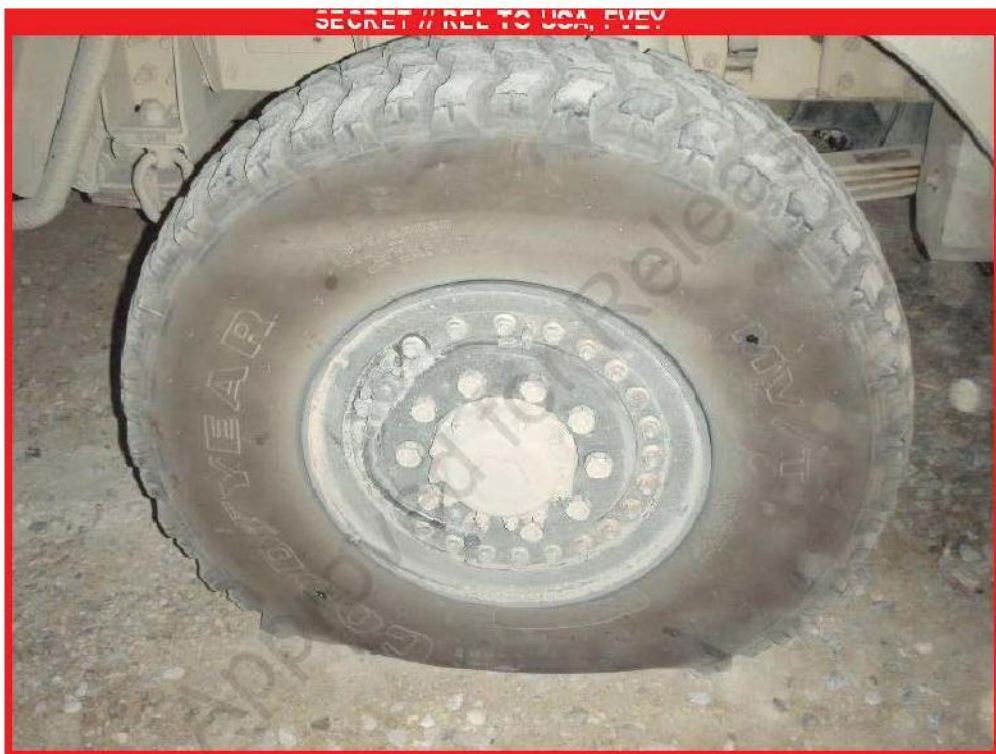
TC Side front tire

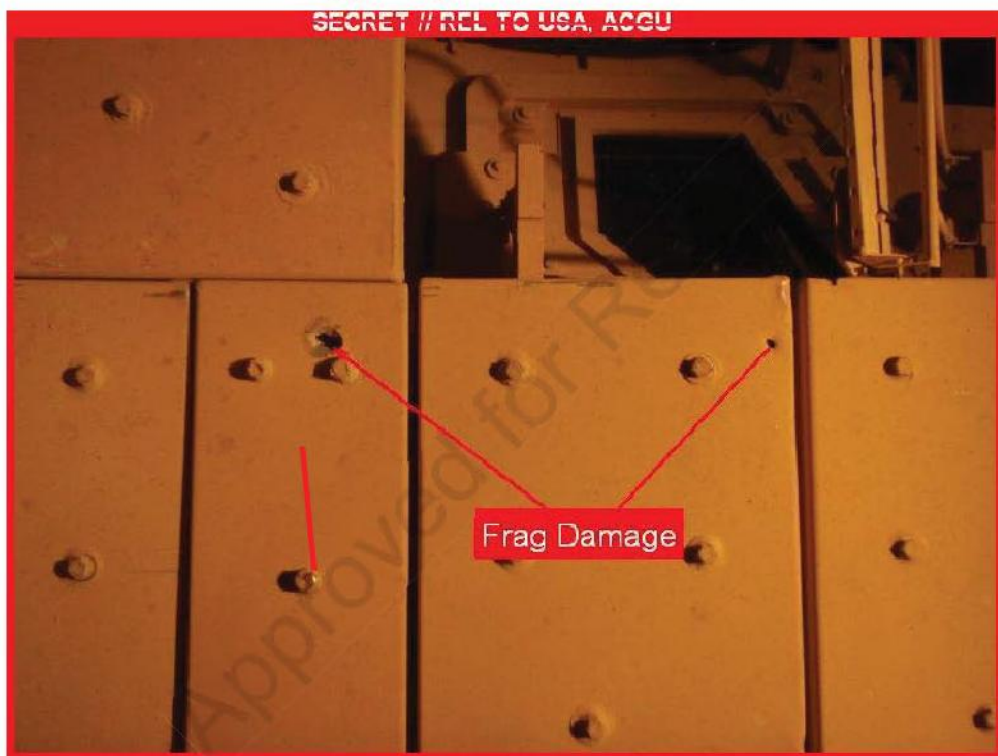
Secondary Fragmentation damage to TC Side

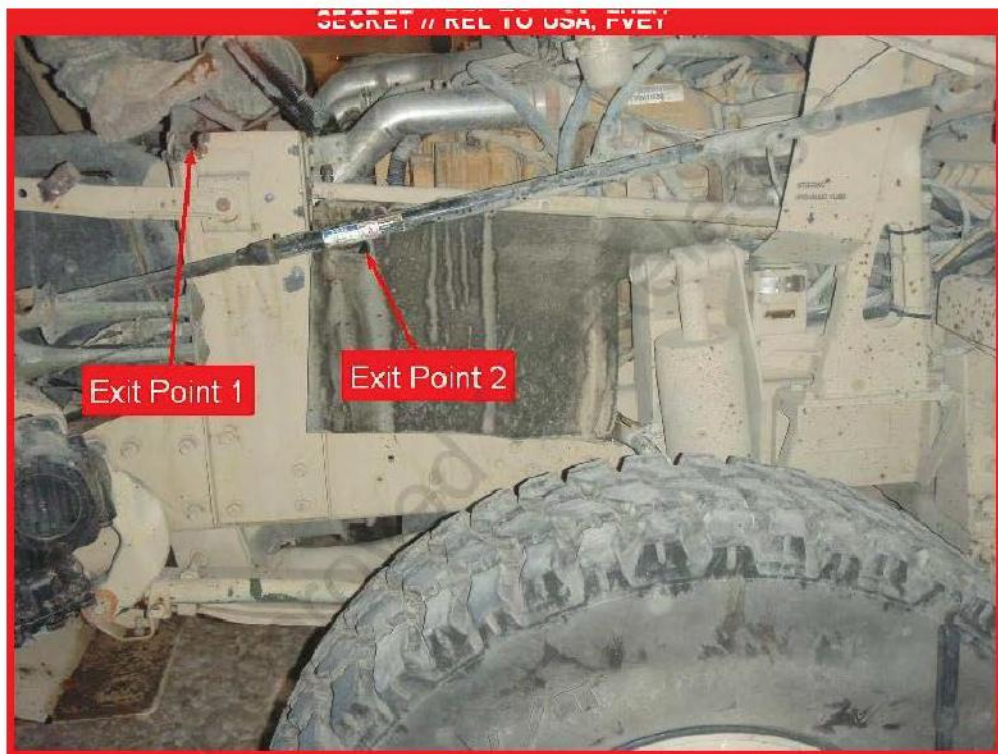
Driver Side (Inside)

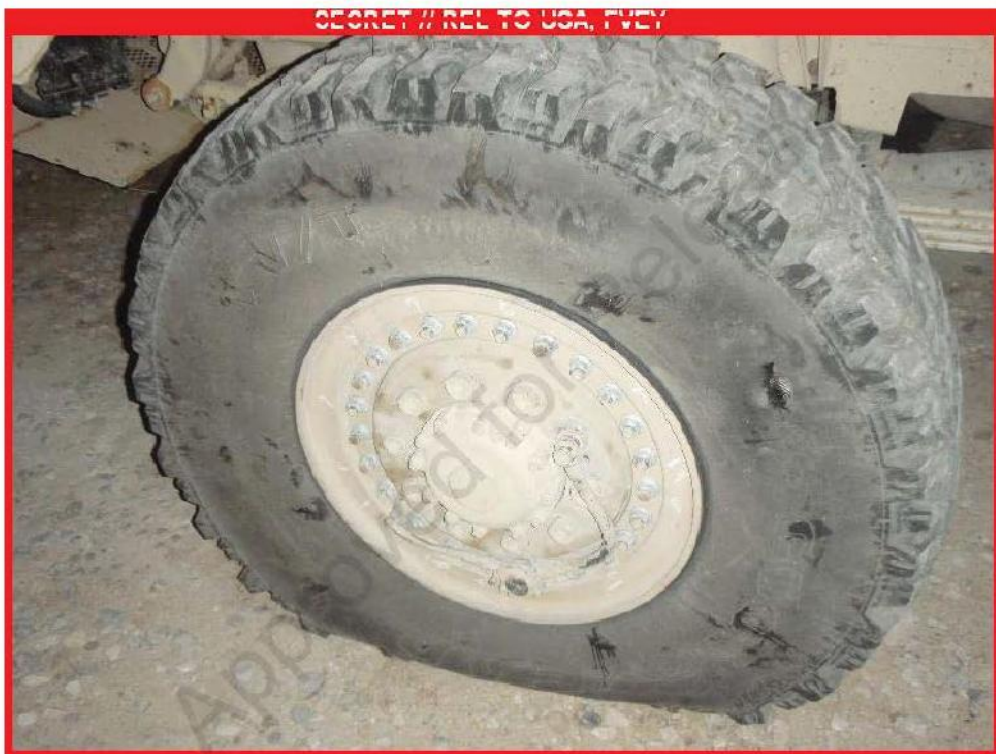
Driver Side front tire

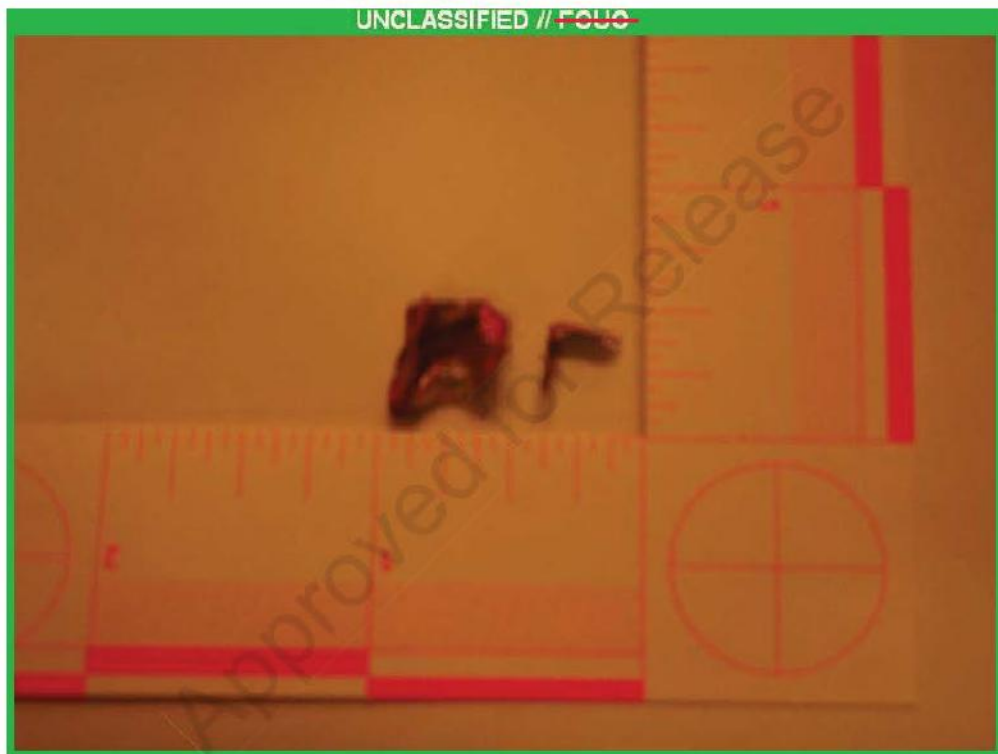
recovered from engine compartment.
